## Fuselage

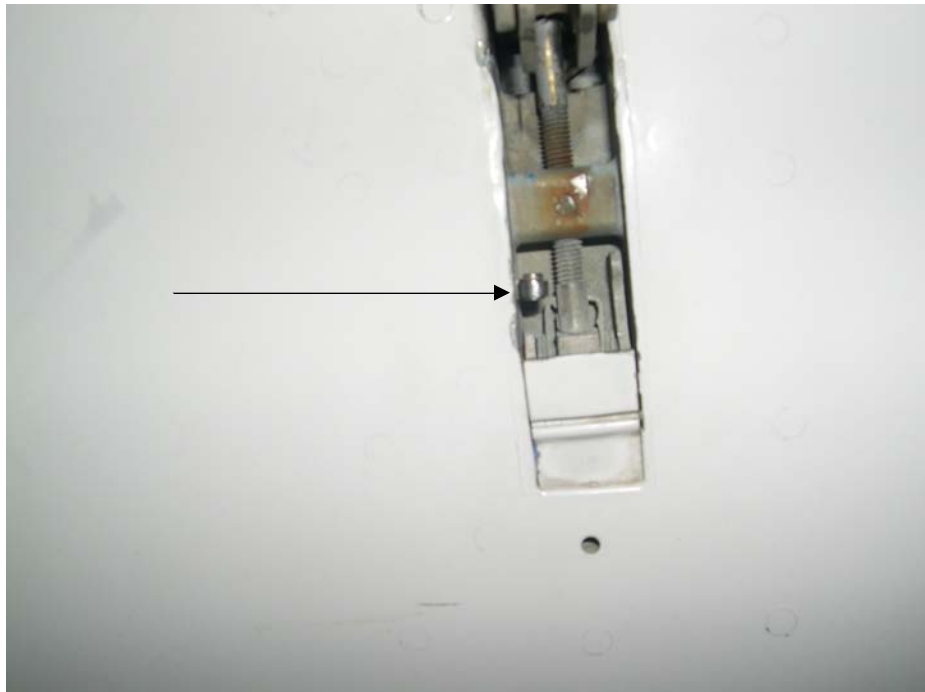
**Door not Locked Microswitch, on latch (early style)**

Behind the avionics compartment is the nose baggage compartment. This area is accessible through two baggage doors which are hinged at the top. Typical baggage capacity is 350 lbs, but there may be some variation due to avionics installed. A placard will display the nose baggage capacity. Nose baggage doors are each armed with a micro-switch that illuminates the "DOOR NOT LOCKED" annunciator light on the annunciator panel in the cockpit. On early airplanes, these micro-switches are located on the forward latches on these doors. Switches installed on the forward latches do not notify the crew if one of the key locks is not engaged. They do notify the crew if the forward latch is not secure. On later airplanes, these micro-switches are located on the locks themselves. This switch position notifies the crew only that one or more of the doors are not key locked. The key position switch does not notify the crew of an unsecured latch. Some modified aircraft have had the key switches added, leaving the latch switches as installed at the factory, the best arrangement of all, but quite rare. On later models, the annunciator light identifies the specific door unlocked such as "BAGGAGE DOOR L or R", "CABIN DOOR" or "AFT BAG DOOR". On earlier models, the switches all report to the same "DOOR NOT

LOCKED” annunciator, meaning you must locate the offender by trial & error.

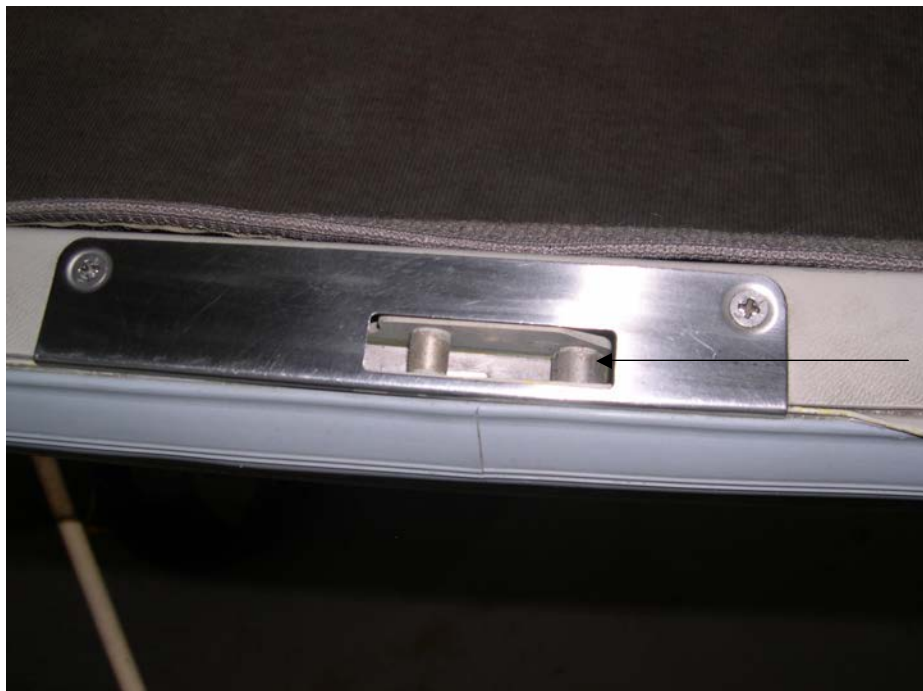
**Later style switch on key lock**

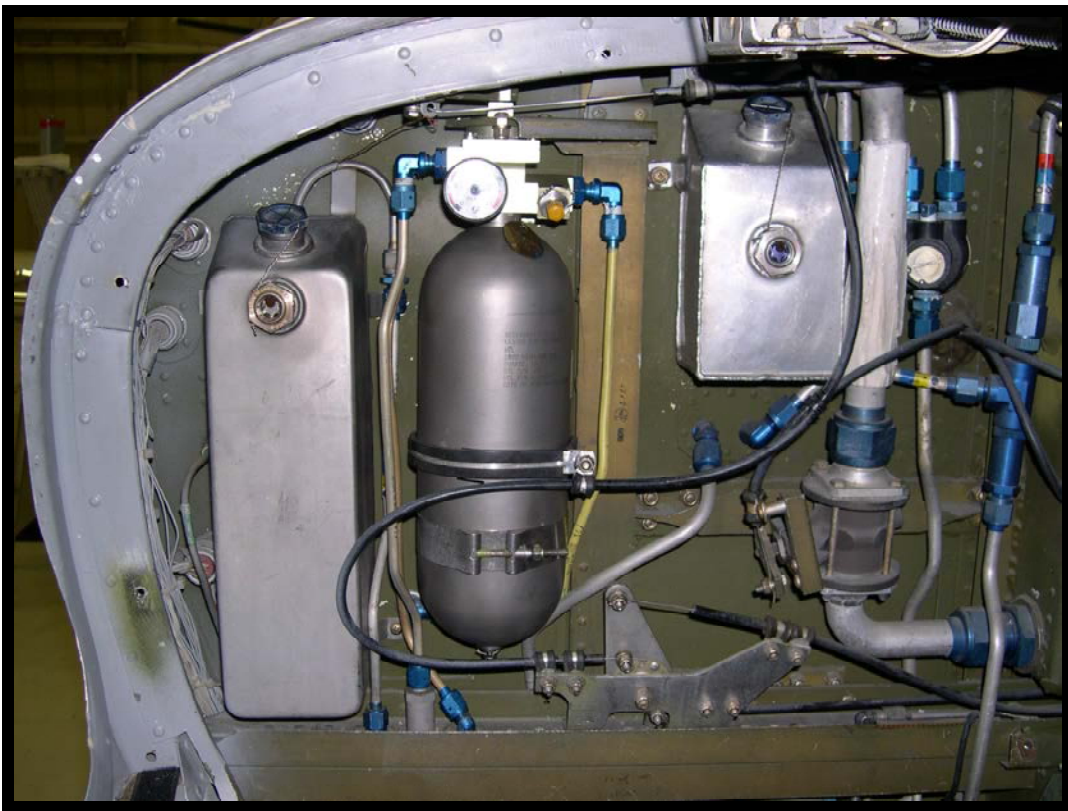
A pressure gauge is installed on a pneumatic bottle which contains nitrogen used to operate wheel brakes in the event of hydraulic brake failure. This bottle can also be used to insure that the landing gear are locked down should it be necessary to extend the wheels by the alternate means due to a hydraulic or electrical failure.

The forward pressure bulkhead is essentially the aft wall in the nose baggage compartment. Located on this bulkhead are numerous sight gauges which allow the crew to inspect certain systems during walk around as follows.

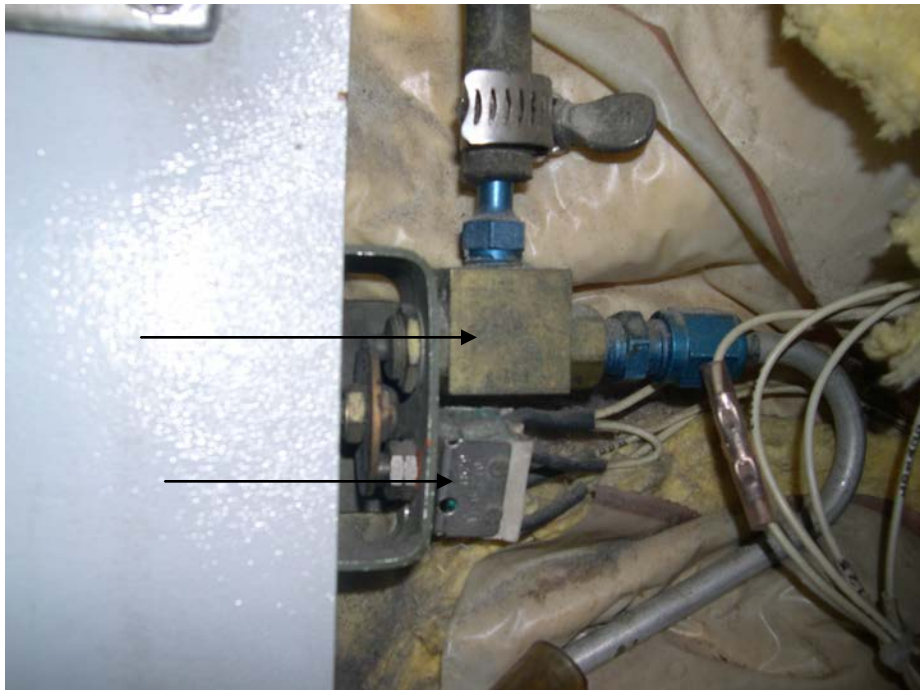
**Cabin door seal checkvalve, upper arrow  
and “Door Not Locked” microswitch, lower**

Behind the forward pressure bulkhead are the flight compartment and cabin. Both are accessed through the main cabin door on the left side of the fuselage. This door opens out and forward and is supported by a single forward hinge. The door can be opened from within or from outside. The door is held closed by 12 locking pins. Painted onto the two upper and two lower locking pins are position marks which are visible through 4 inspection windows on the inside of the door near the pins. These green dots indicate that

those 4 pins are in their locked position. The other 8 locking pins are located on the fore and aft side of the door. They are attached to two position indicators, front 4 pins to one indicator and the aft 4 pins to the other. When these 8 pins are extended, the two position indicators (aligned white horizontal lines) are visible in a single viewing window just left of the inside door handle. When the two white lines are aligned and the 4 green dots are visible, the door is secure. The lower forward locking pin depresses a micro-switch located in its receiver when the door is secured. This switch must be closed to extinguish the “DOOR NOT LOCKED” annunciator light. This pin also depresses a plunger allowing regulated bleed air to enter the inflatable door seal and trap it there by check-valve action until the door is opened. The main cabin door can also be key locked from the outside for security.

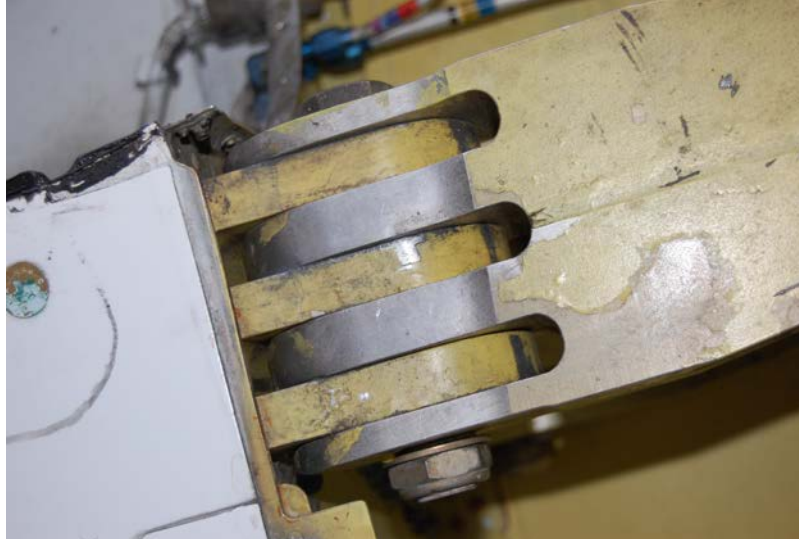
**Wing attach bolt**

and attached to the stub wing with four very important bolts, one of which is pictured below and is visible from underneath the wing.
